**HUDSON RIVER BASIN
SANDGATE**

**LAKE MADELEINE
VT 00007**

**PHASE I INSPECTION REPORT
NATIONAL DAM INSPECTION PROGRAM**

**DEPARTMENT OF THE ARMY
NEW ENGLAND DIVISION, CORPS OF ENGINEERS
WALTHAM, MASS. 02154**

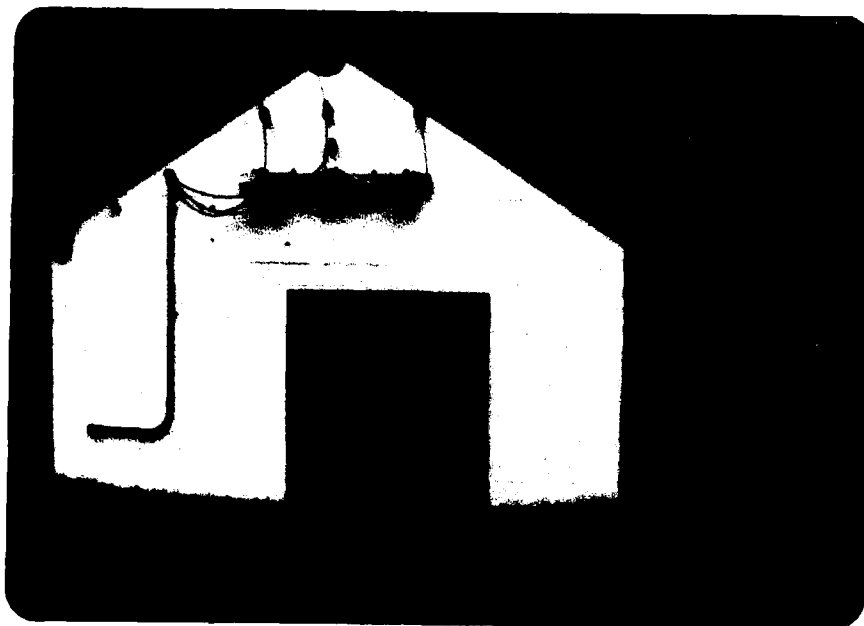
#9 POWER HOUSE No. 1 LOCATED APPROXIMATELY 11,000 FEET
DOWNSTREAM OF LAKE MADELEINE DAM.
